**Building Safety Certificate**

**Name of School – Mary Memorial International School, of Indian Society For social Action,  
Daund, Pune.**

**STRUCTURAL SAFETY REPORT FOR  
MARY MEMORIAL INTERNATIONAL SCHOOL, OF  
INDIAN SOCIETY FOR SOCIAL ACTION. DAUND,  
PUNE.**

## **Structural Report of Mary Memorial International School, of Indian Society for Social Action. Daund, Pune.**

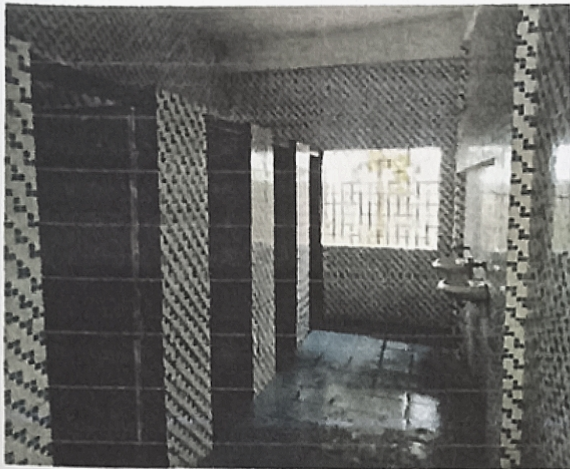
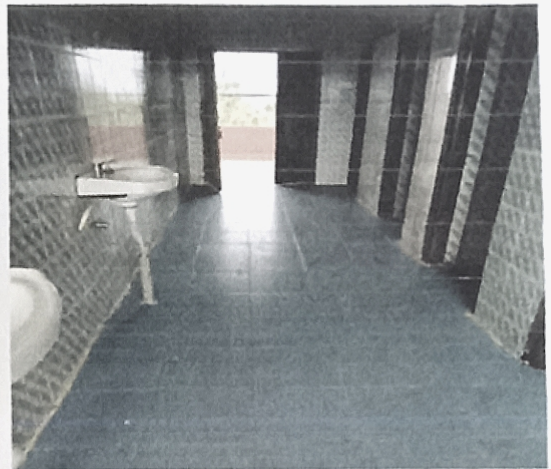
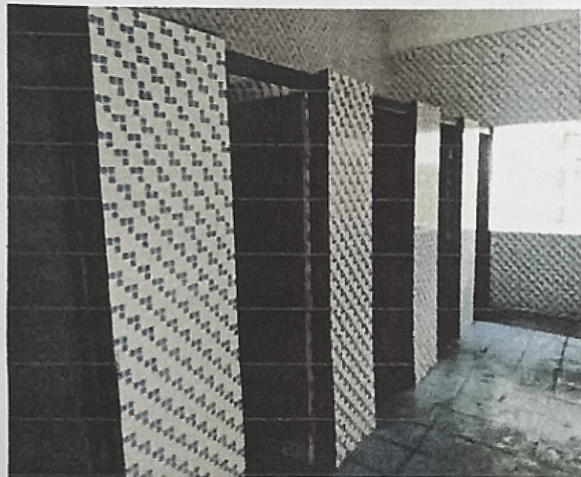
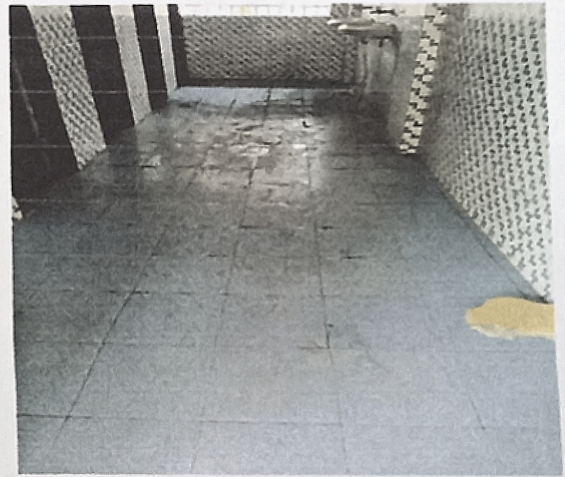
Toilets

- All sanitary units in toilets are good and proper working condition. No leakages observed. Frequent maintenance shall be carried out.
